Environmental Conditions Summary

East Village Precinct, Bentleigh East

19 September 2017

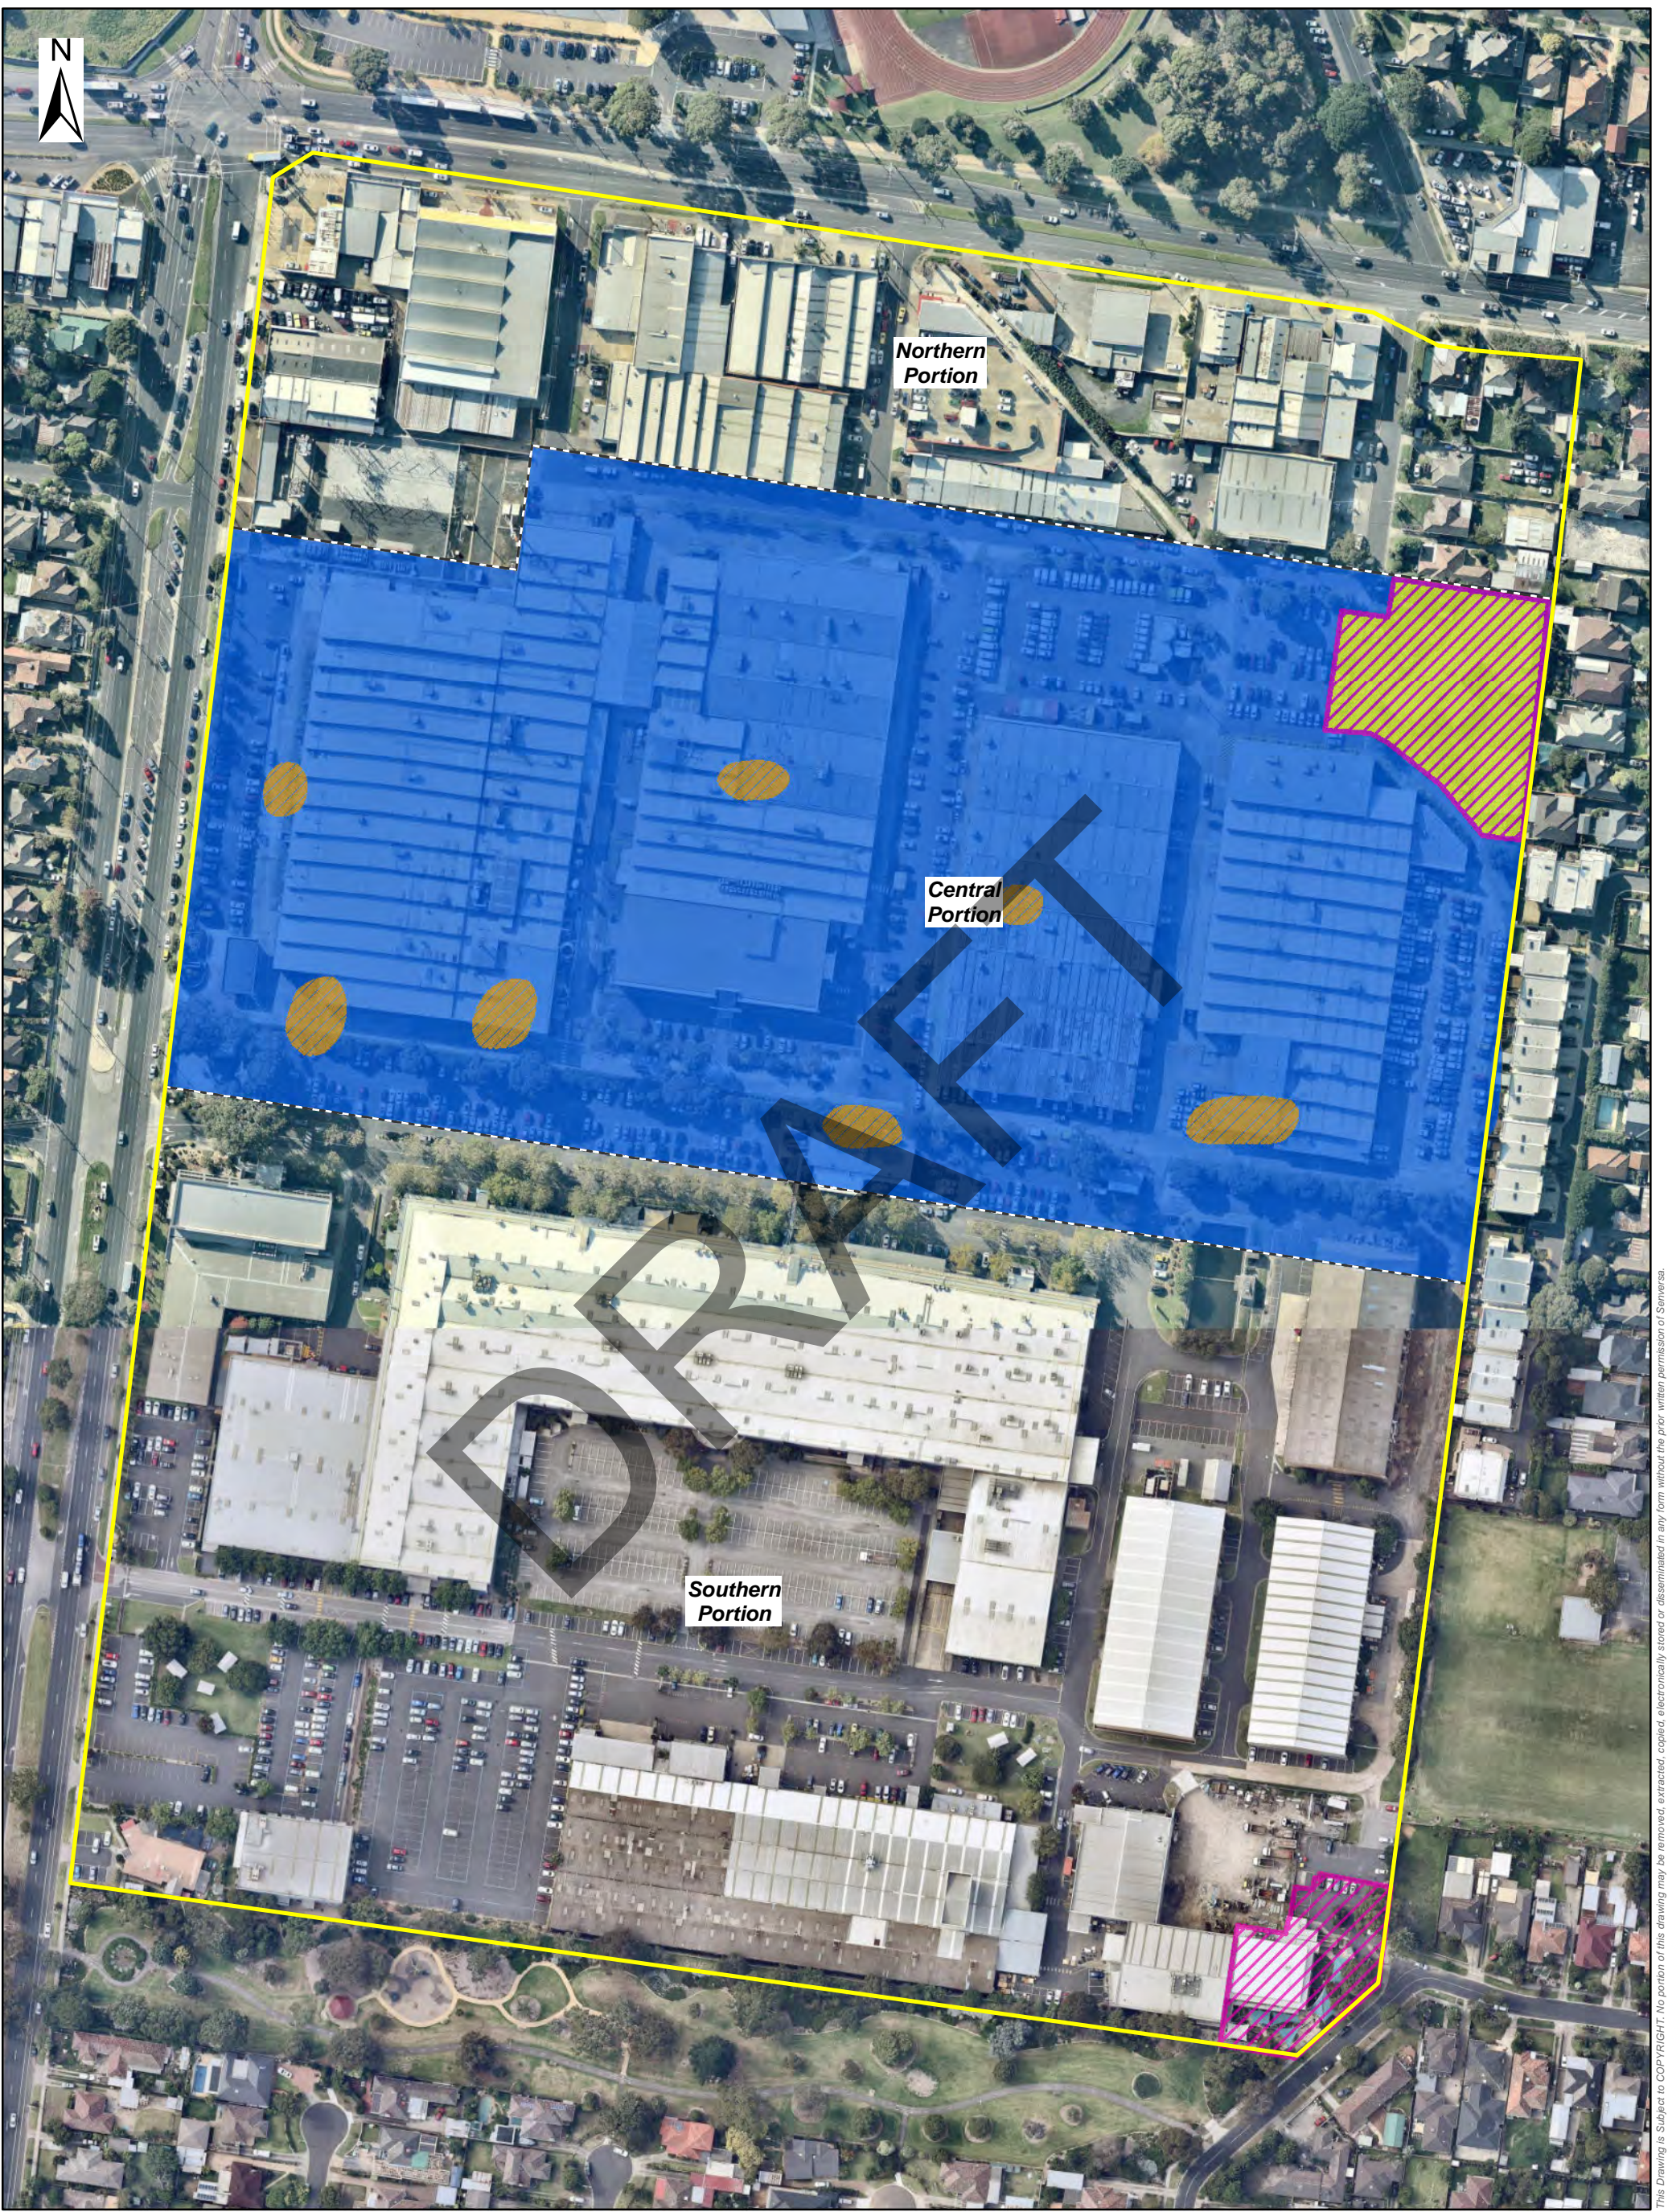
Figure No:	1
Title:	Summary of Environmental Conditions
Project:	Project
Location:	East Village Strategic Site, Bentleigh East
Client:	VPA

Soil and groundwater remediation in the form of in situ chemical oxidation (ISCO) has previously been undertaken in areas of soil and groundwater found to be the most heavily impacted by chlorinated solvents in former Plants 1, 2, and 4 in the central portion of the Precinct. Measurable decreases in chlorinated hydrocarbon concentrations were measured in groundwater following the ISCO remedial attempts, however these decreases did not generally persist and further remediation of the seven impacted soil areas and groundwater within the central portion of the Precinct (as shown on **Figure 1**) will be required as a part of the redevelopment of the Precinct.

For the identified impacted soil and groundwater area shown on **Figure 1**, potential management / remediation measures that may be able to be employed (potentially more than one) to manage potential risks the future development include one or more of the following:

- Soil source remediation – Excavation, off-site disposal and emplacement of carbon source amendment.
- Soil source remediation – Soil mixing and emplacement of carbon source amendment.
- Enhanced groundwater bioremediation with carbon source amendment.
- Enhanced groundwater bioremediation with microbial augmentation.
- Monitored natural attenuation with source remediation.
- Permeable reactive barrier.
- Hydraulic control.
