East Village Peer Review and Phase 1 Environmental Site Assessment

East Village, Bentleigh East, VIC 3165 Victorian Planning Authority

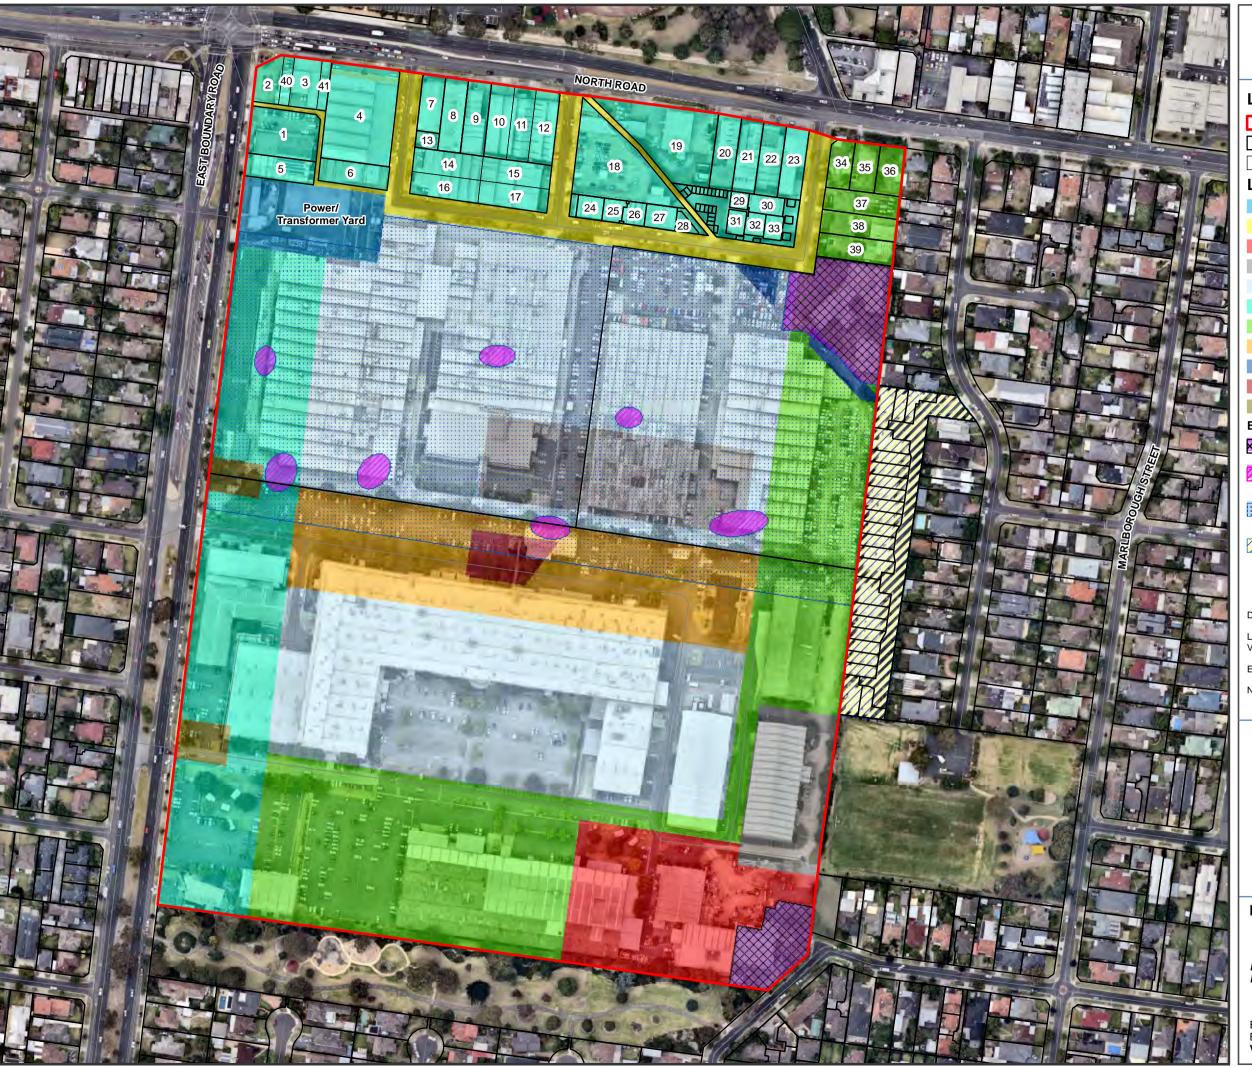
According to these records, one of the audit sites is located within the southern portion of the Precinct (CARMS No. 58597-1: 236-262 East Boundary Road, Bentleigh East) and one audit site is located immediately adjacent to the east of the Precinct (CARMS No. 70850-1: 27 Dromana Avenue, Bentleigh East). The audit site located at 27 Dromana Ave is noted to have an EPA Groundwater Quality Restricted Use Zone (GQRUZ). The location of these audit sites are shown on **Figure F3**.
